REHABILITATION OF DOLOW ADMINISTRATION AND COMMUNITY CENTRE

IOM Reintegration and Durable Solutions (RDS) Unit

Drawing Tittle:		Revision No.		
INDEX SHEE	т			
Drawn by: A.K	Checked & Approved by: Hassan Abdisamad	Sheet No. G-01	Scale: N/A	
Date: July 2018 ARCHITECTURAL DRAWINGS

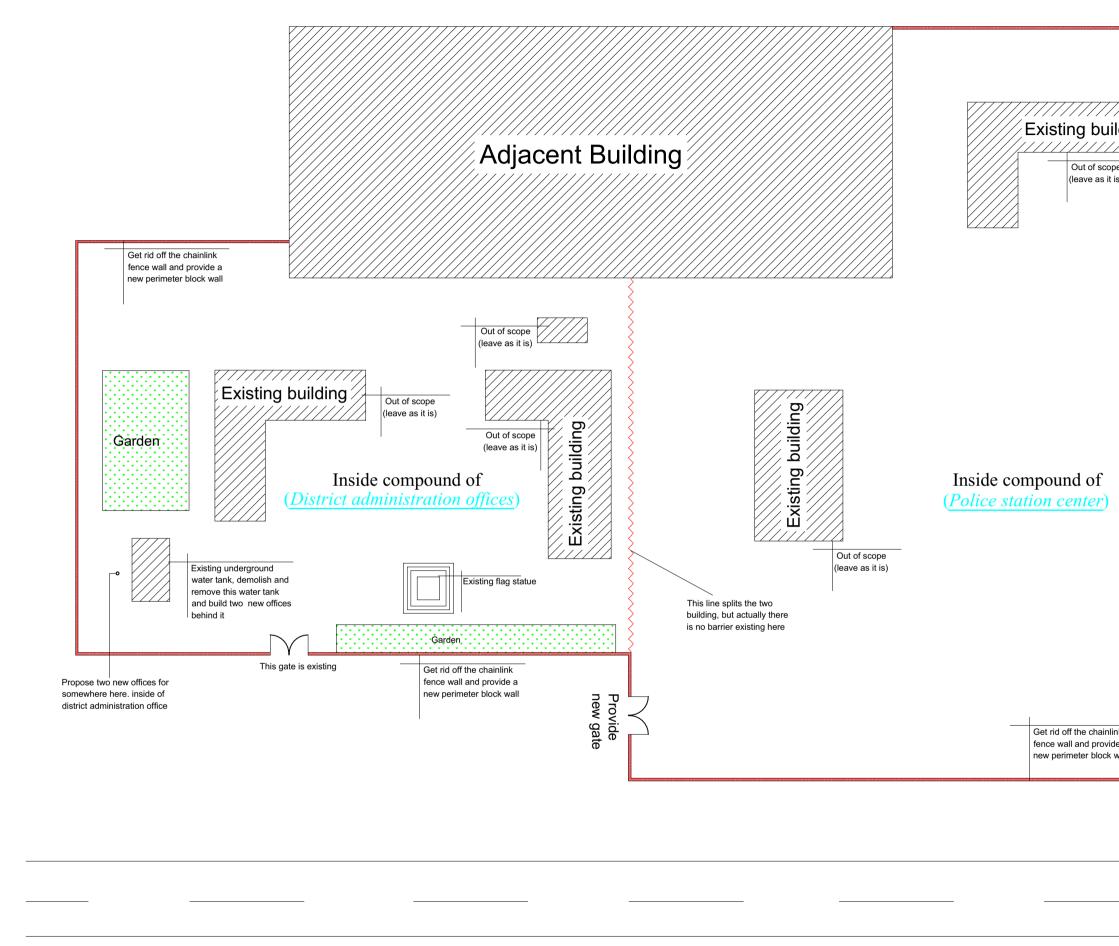
Get rid off th fence wall ar new perimete	nd provide a			
t of scope ve as it is)				
	Get rid off the chainlink fence wall and provide a new perimeter block wall			
of <u>ter</u>)				
e chainlink Id provide a er block wall				
Drawing Tittle: EXISTING S	ITE PLAN		Revision No.	
Drawn by:	Checked & App	proved by:	Sheet No.	Scale:
A.K	Hassan Abdis		A-01	1:300

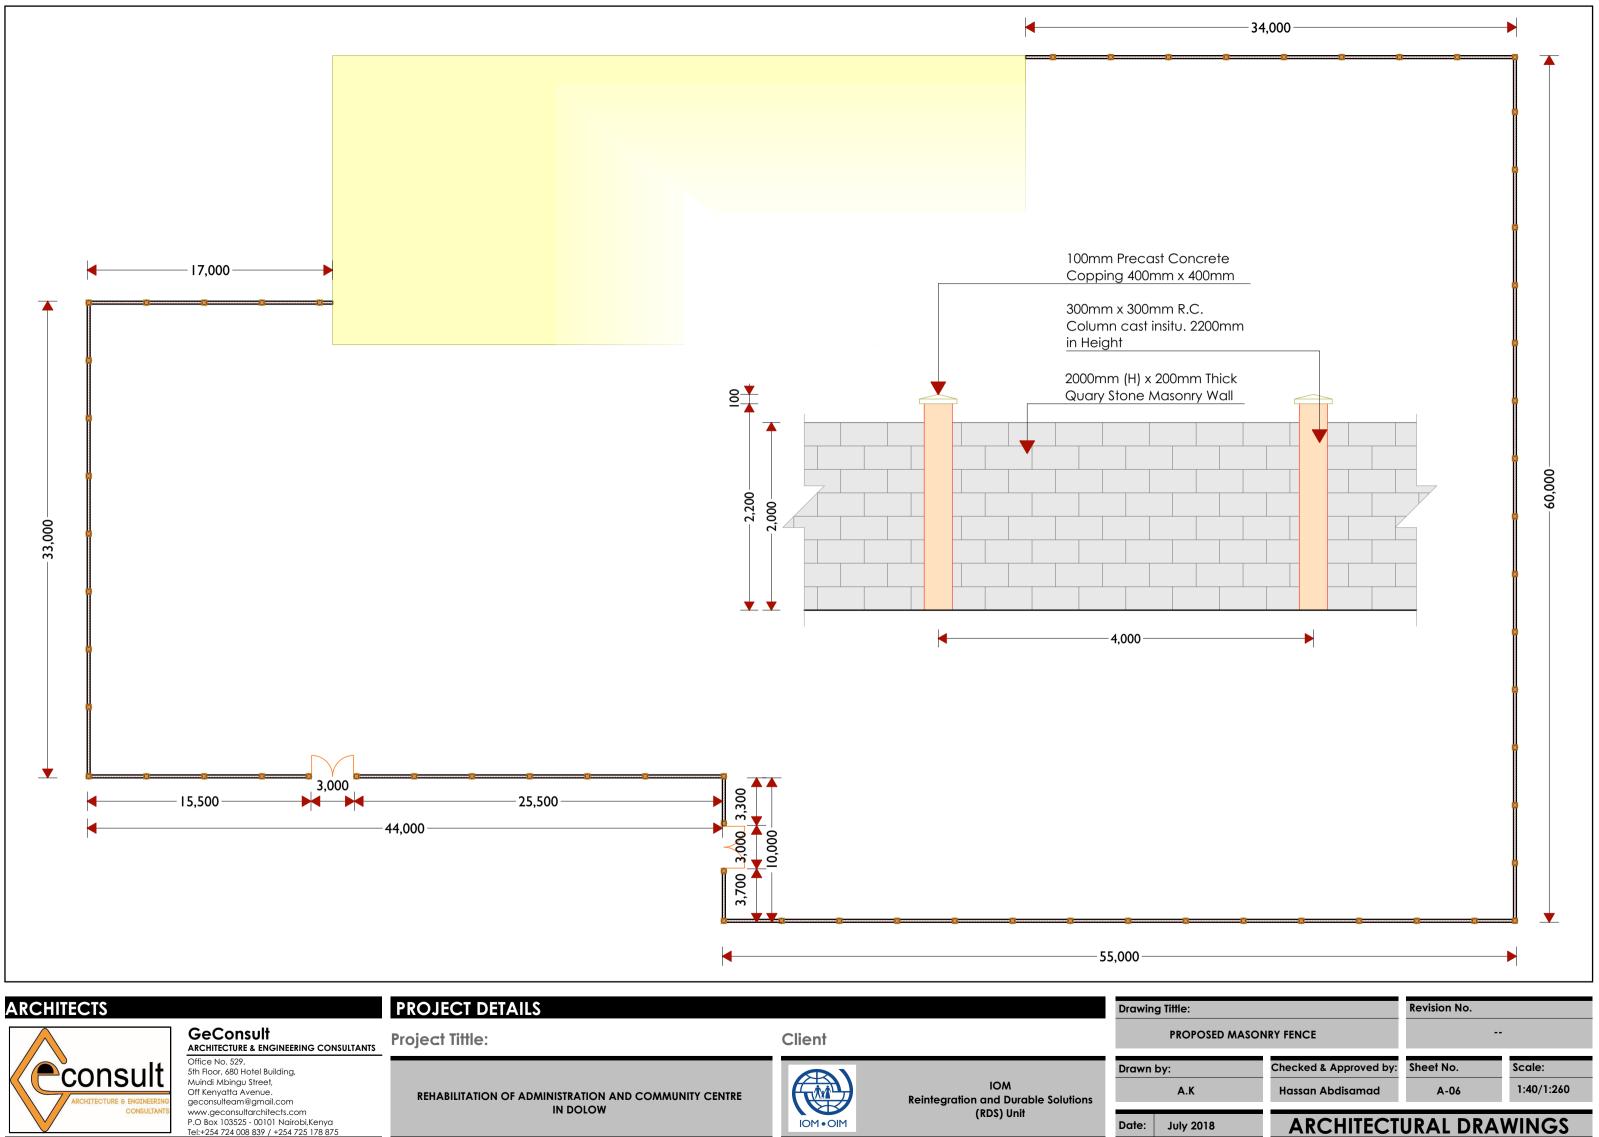
Drawing Tittle:		Revision No.		
OPENINGS SC	HEDULE			
Drawn by:	Checked & Approved by:	Sheet No.	Scale:	
A.K	Hassan Abdisamad	A-07	1:50	
Date: July 2018	ARCHITECTURAL DRAWINGS

OPENING IMAGE	NAME	QTY	WIDTH	HEIGHT	Γ
	D-01	2	900	2400	M.S. Pa with loc amd 3 v
	W-01	4	1500	1500	M.S. Cas with Lou and side and a to above t
	G-01	1	3000	2000	M.S. Pa Gate b x300mn either si

DESCRIPTION

anel Swing Door ckable door latch welded hinges

asement Window uvred main sash le hung side sashes top hung transom the touvres

anel Double Swing oolted to 300mm m R.C. Columns on side

Replace the Existing Police Station Gate With a new M.S. Panel double Swing Gate as per opening schedule

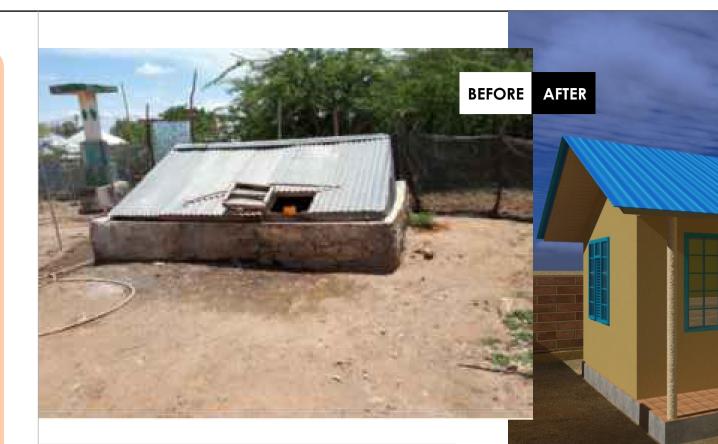
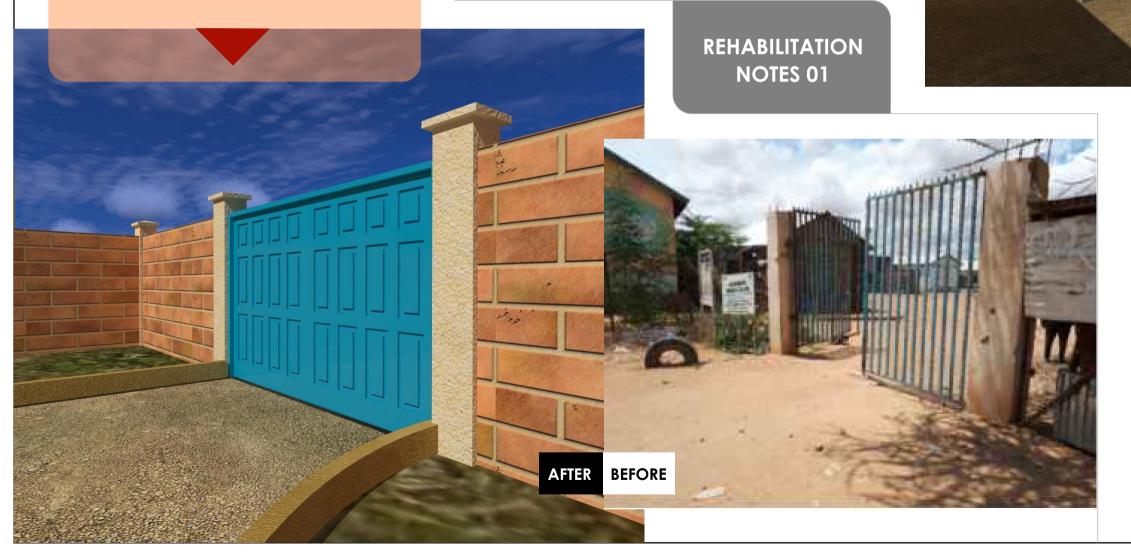
Clear Bushes and dirt around the gates, level and introduce new parking spaces outside the two gates as per drawing provided

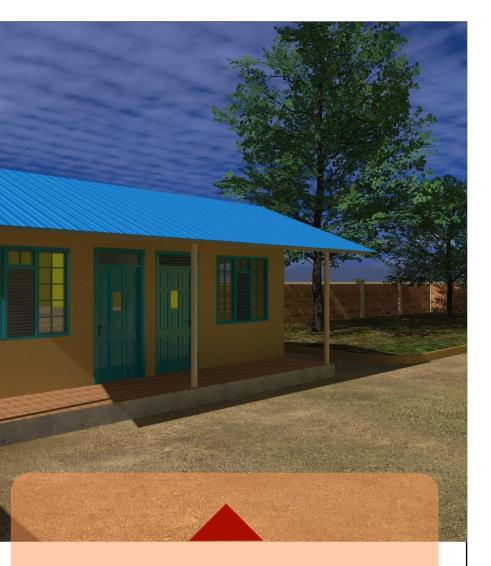
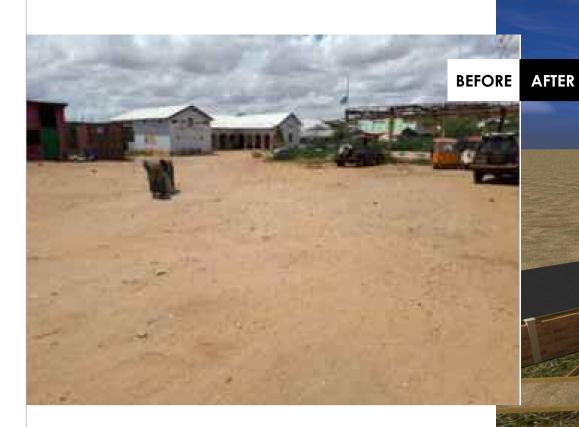
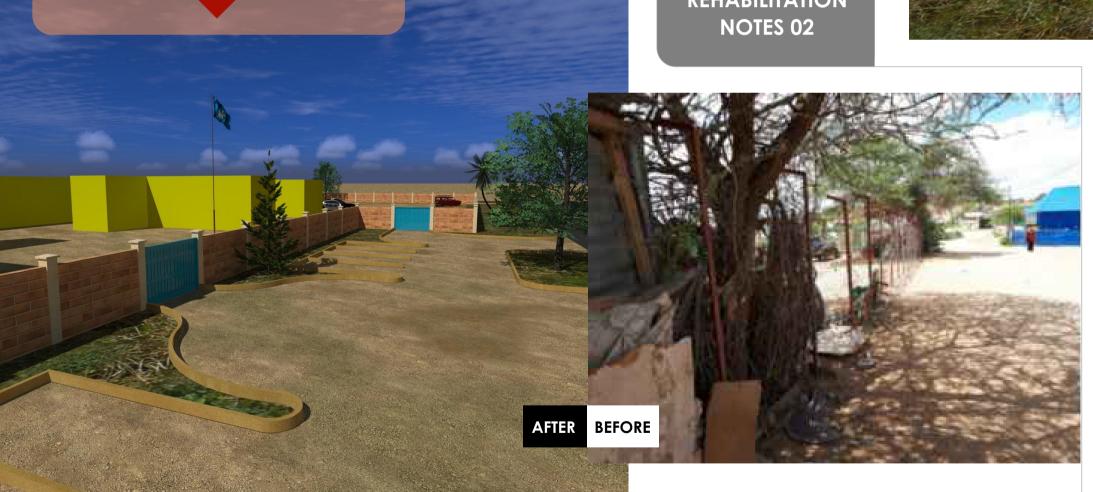
Drawin	g Tittle:		Revision No.	
REHABILITATION NOTES 01				
Drawn	by: A.K	Checked & Approved by: Hassan Abdisamad	Sheet No. A-08	Scale: N/A
Date:	July 2018	ARCHITECTURAL DRAWINGS

Demolish existing undergound tank.

Cart away debri, level and compact ground ready for new foundation for the proposed new 2 Offices Block

Construct a 2 Offices block where the underground tank used to be as per the drawings provided.

Replace the Existing Chain link fence with quary stone masonry wall 2000mm high as per the proposed drawings with 300mm x 300mm R.C. Columns at 4000mm centres

Clear Bushes and dirt around the gates, level and introduce new parking spaces outside the two gates as per drawing provided

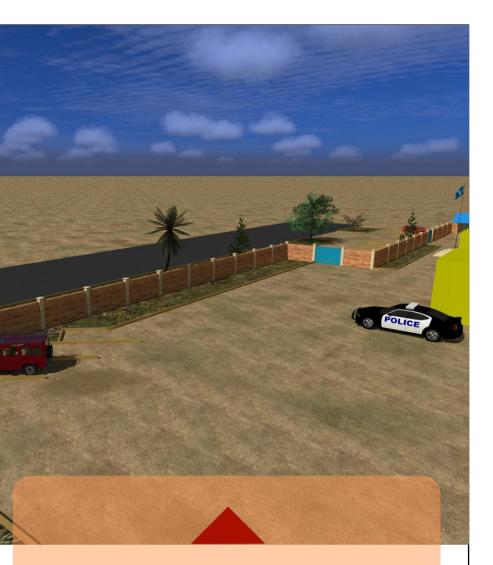
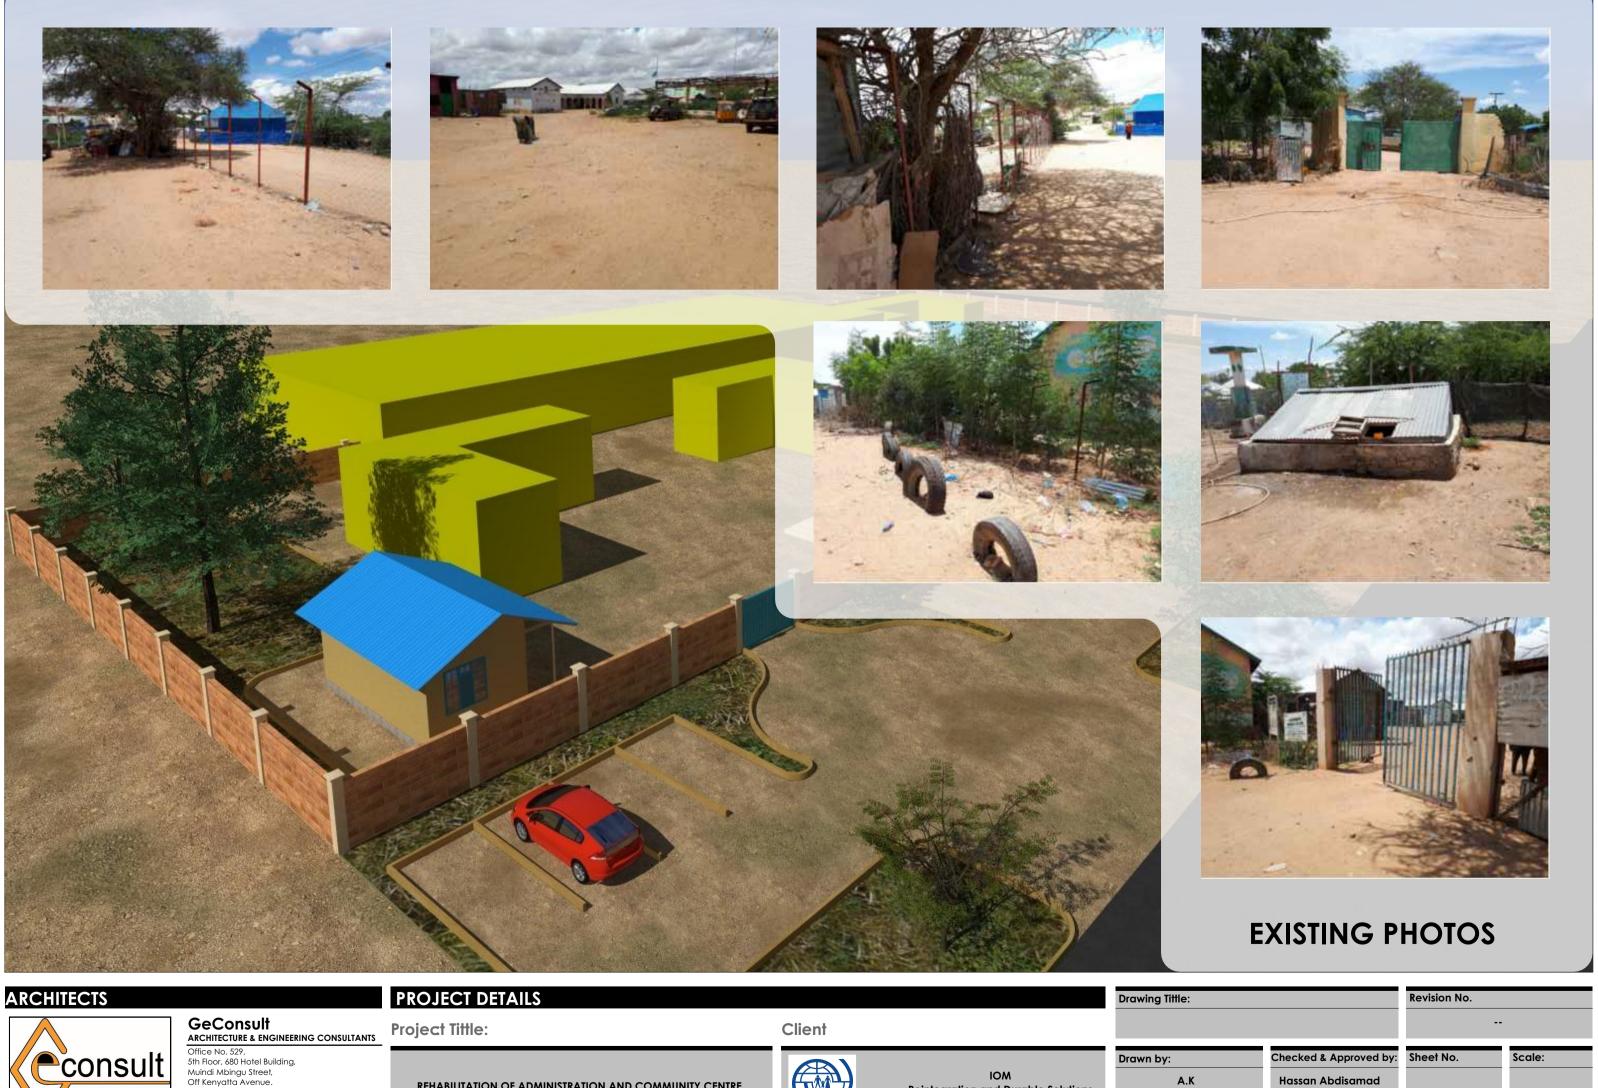
Drawin	g Tittle:		Revision No.	
	REHABILITATION I	ON NOTES 01		
Drawn	by: A.K	Checked & Approved by: Hassan Abdisamad	Sheet No. A-09	Scale: N/A
Date:	July 2018	ARCHITECTURAL DRAWINGS

Clear the site of all unwanted dirt. bushes and debri.

Level the site to architects aprooval. Introduce defined Parking inside the police station. Introduce proper tree gardens / landscaped areas as per proposed drawings
