MARKA DISTRICT CENTER REHABILITATION

PROPOSED REHABILITATION OF MARKA DISTRICT CENTER

-MARKA TOWN-

August 2019

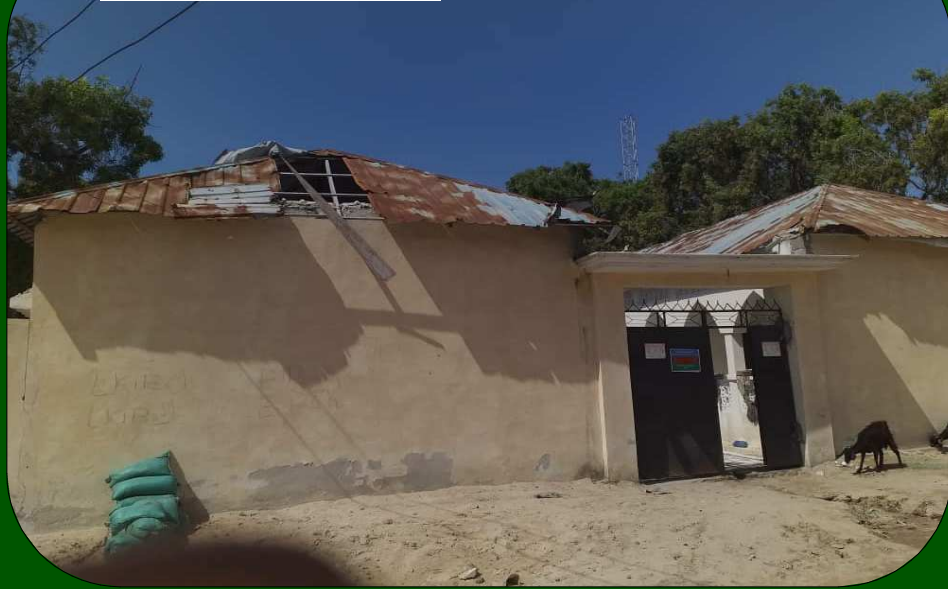
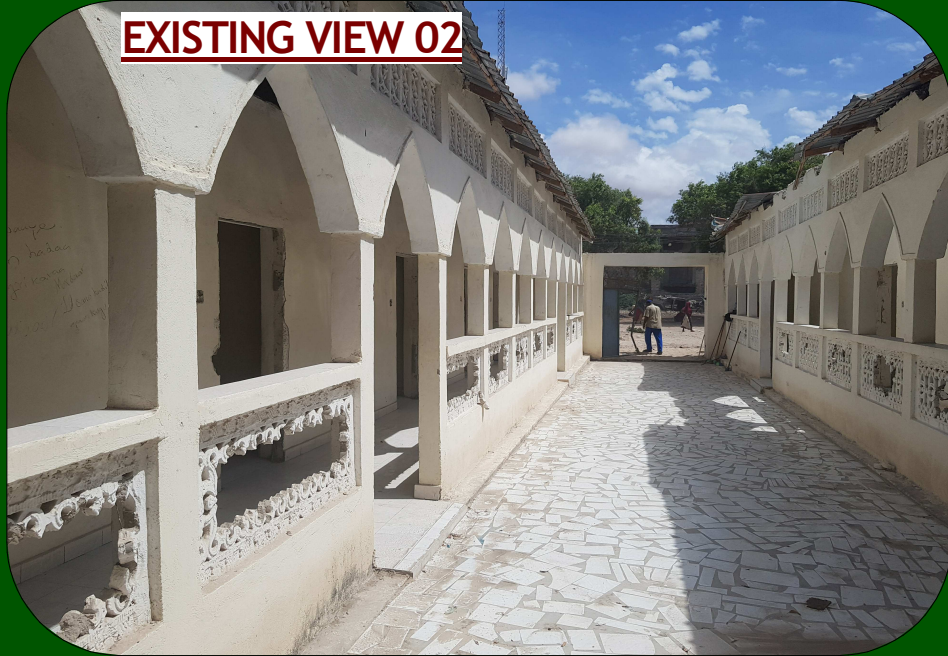
EXISTING VIEW 01

- The wall are faded out of paint and patches of wall are eroded around the windows
- The plinth had been worn out hence cracking off at the base of the building
- The windows are full of rust and some glass panes are broken and some window members broken like window
- The existing Roof structure of the main building was damaged and it needs to be replaced.

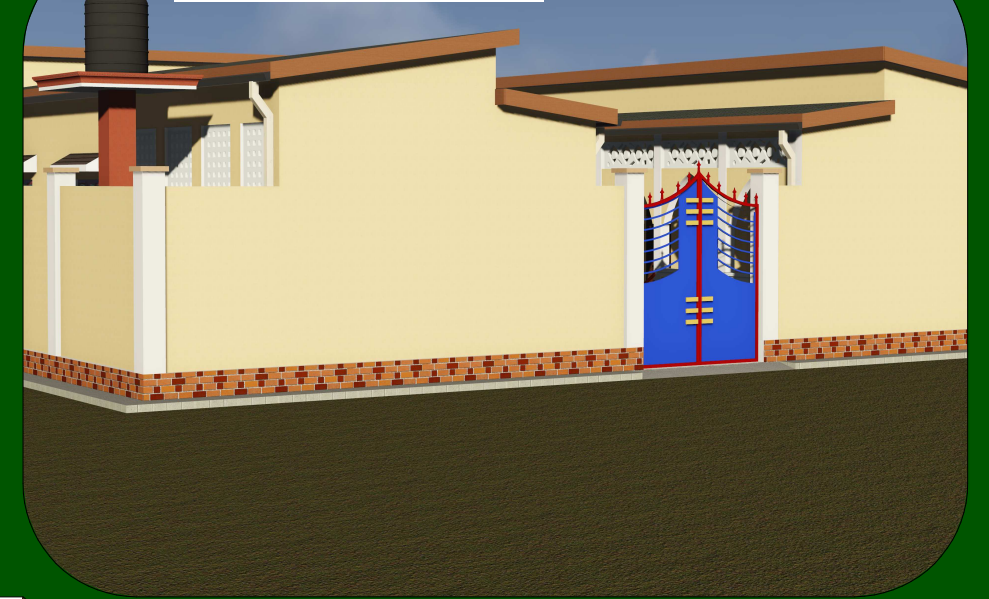
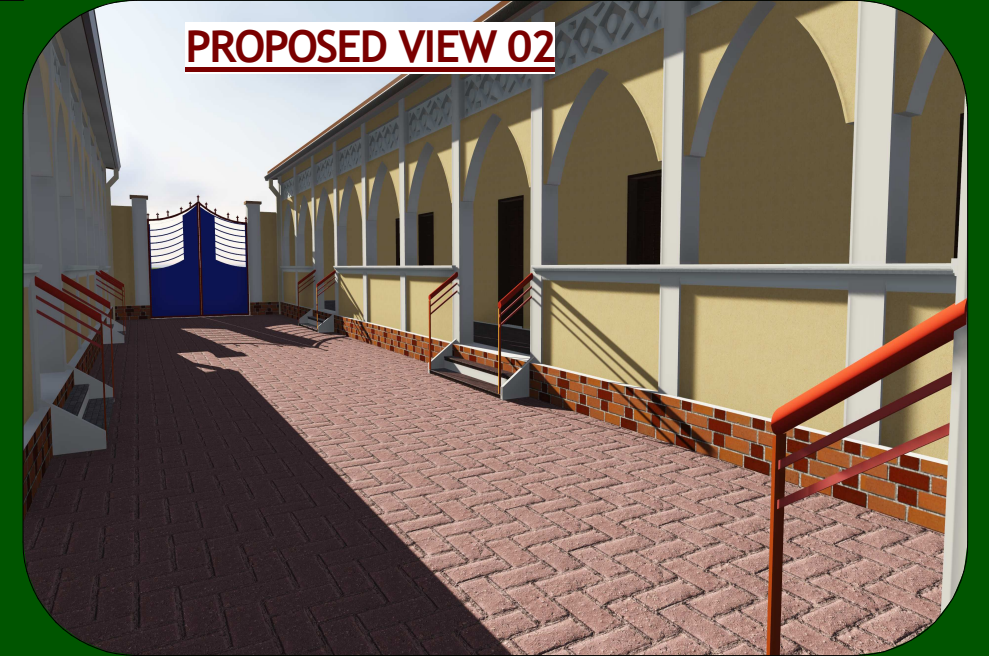
PROPOSED VIEW 01

- The walls to be cleaned, filled with approved cement at the eroded patches, plastered and painted to approval
- The windows to be replace with Almunium windows while maintianing the existing window openings
- The plinth at the base of the building to be cleaned, filled with approved cenment, plastered and painted to approval
- Replace and install new roof structure as per architects approvals

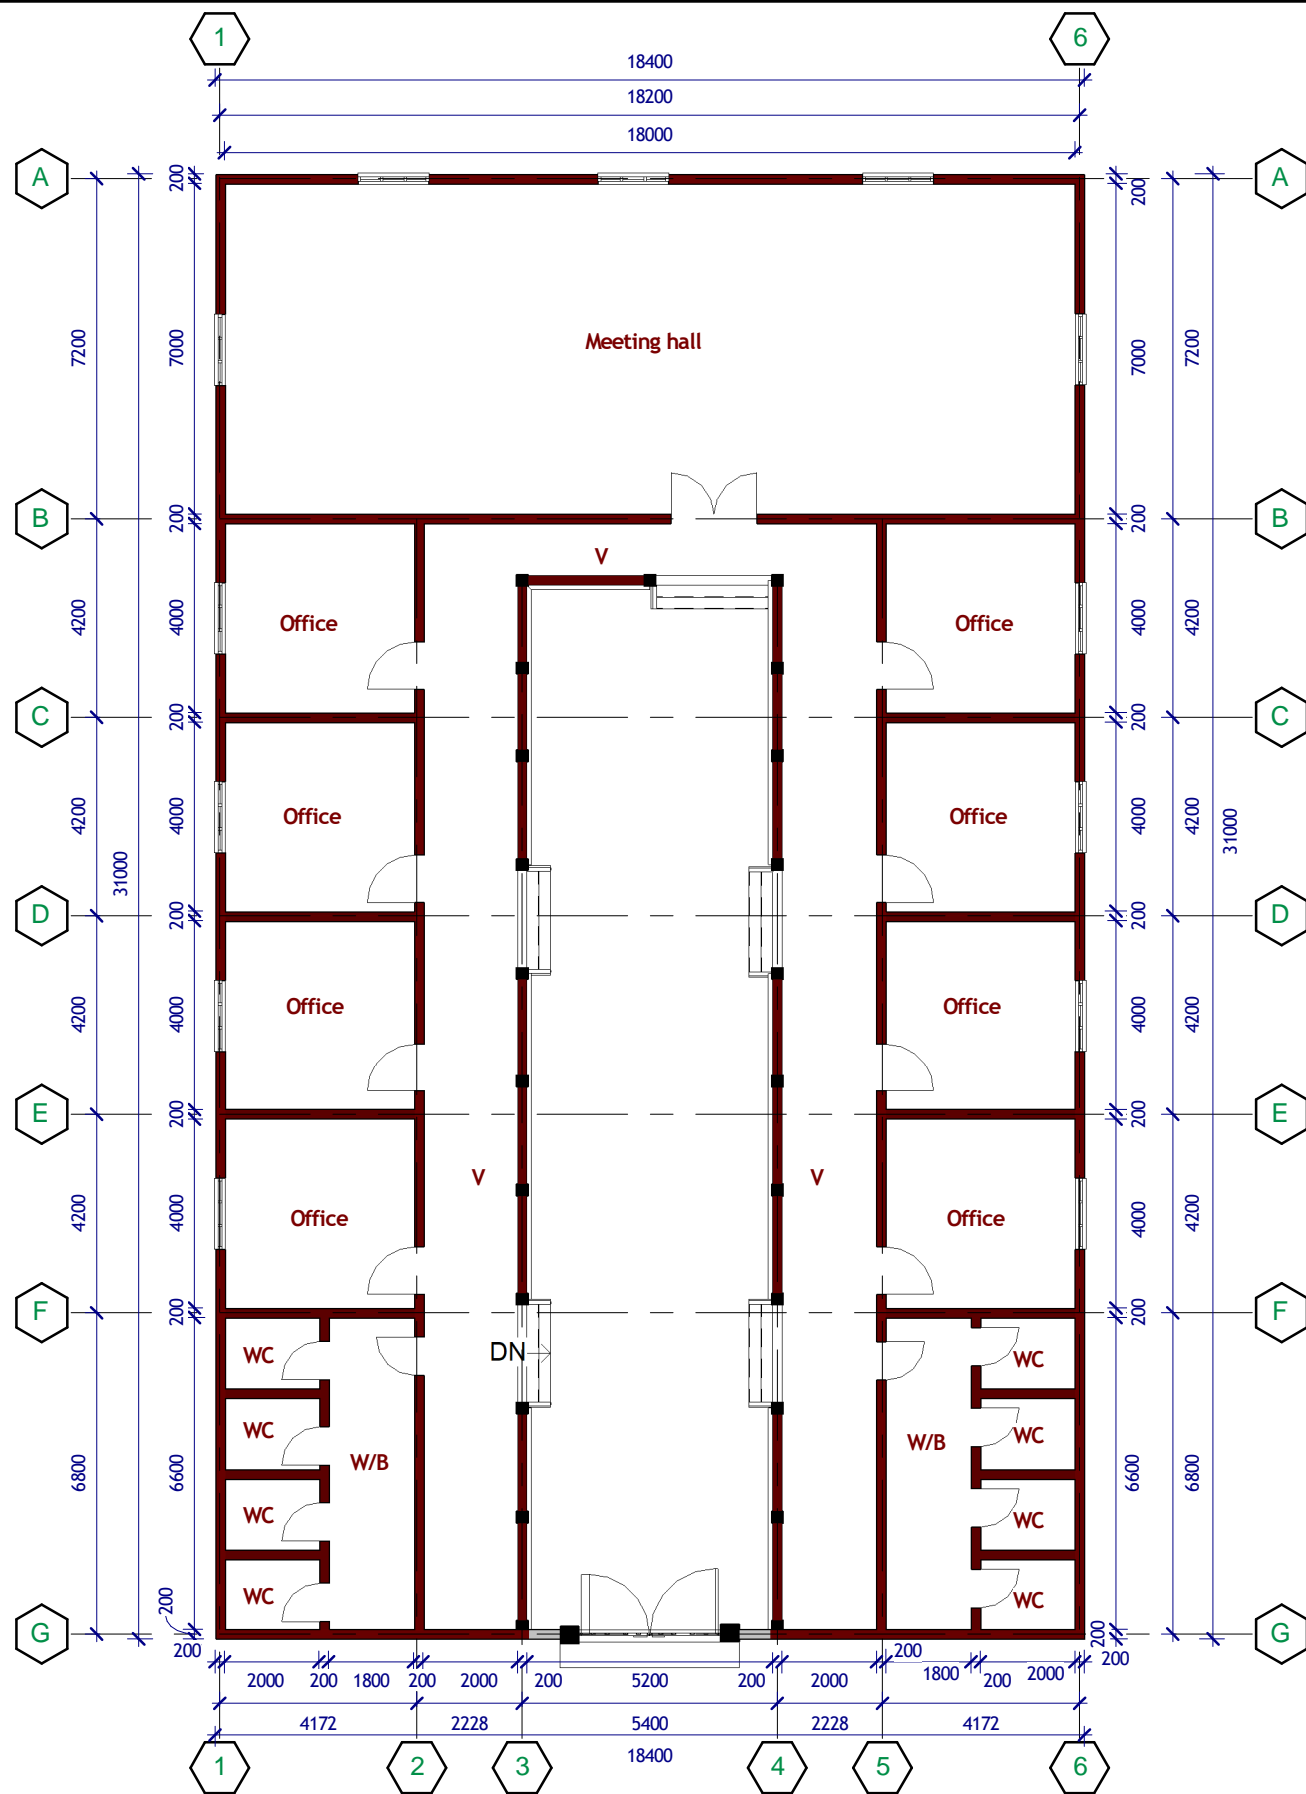
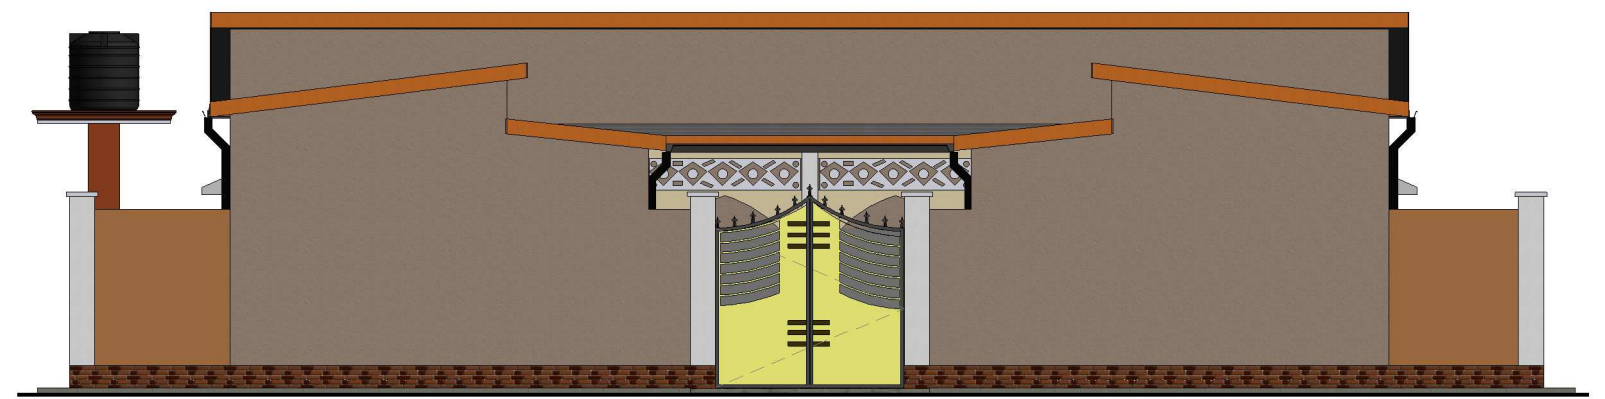
Drawing Title:		MAIN BUILDING FLOOR PLAN
Date: 08/08/2019		
Scale:	Drawing No:	sheet No: 09/16
Designed by: Eng Abdirisak Dirie	Project No:	
	IOM Grant No:

The walls to be cleaned, filled with approved cement at the eroded patches, plastered and painted to approval
